Phase I and II Geoenvironmental Site Assessment
The Three Lions, Mansfield

Reference:14-437-R1-4
Date: July 2023

The Three Lions
11-15 Netherland Lane
Meden Vale
Mansfield
NG20 9PA

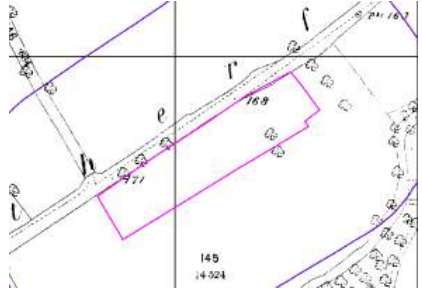
MAP EDITION	HISTORICAL LAND USE	HISTORICAL MAP EXCERPT
1885 1:2,500	The site is open grassland with a few scattered trees present.

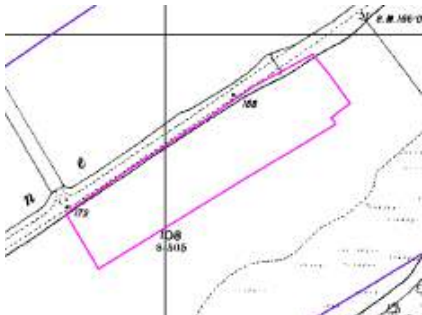
1898 1:2,500	The trees now appear to have been removed. No other significant changes observed.

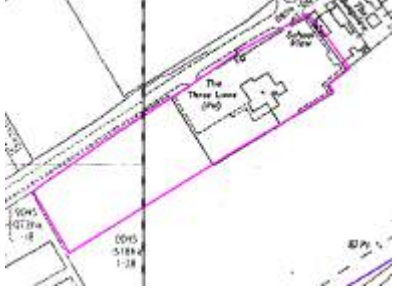
MAP EDITION	HISTORICAL LAND USE	HISTORICAL MAP EXCERPT
<p>1977-1982 1:1,2500</p>	<p>The site is now occupied by the Three Lions public house in the north eastern sector of the site.</p> <p>No other significant changes observed.</p>

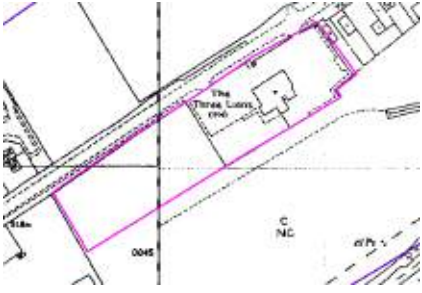
<p>1984-1992 1:2,500</p>	<p>The Three Lions public house appears to have been extended in the north eastern corner of the building.</p> <p>No other significant changes observed.</p>

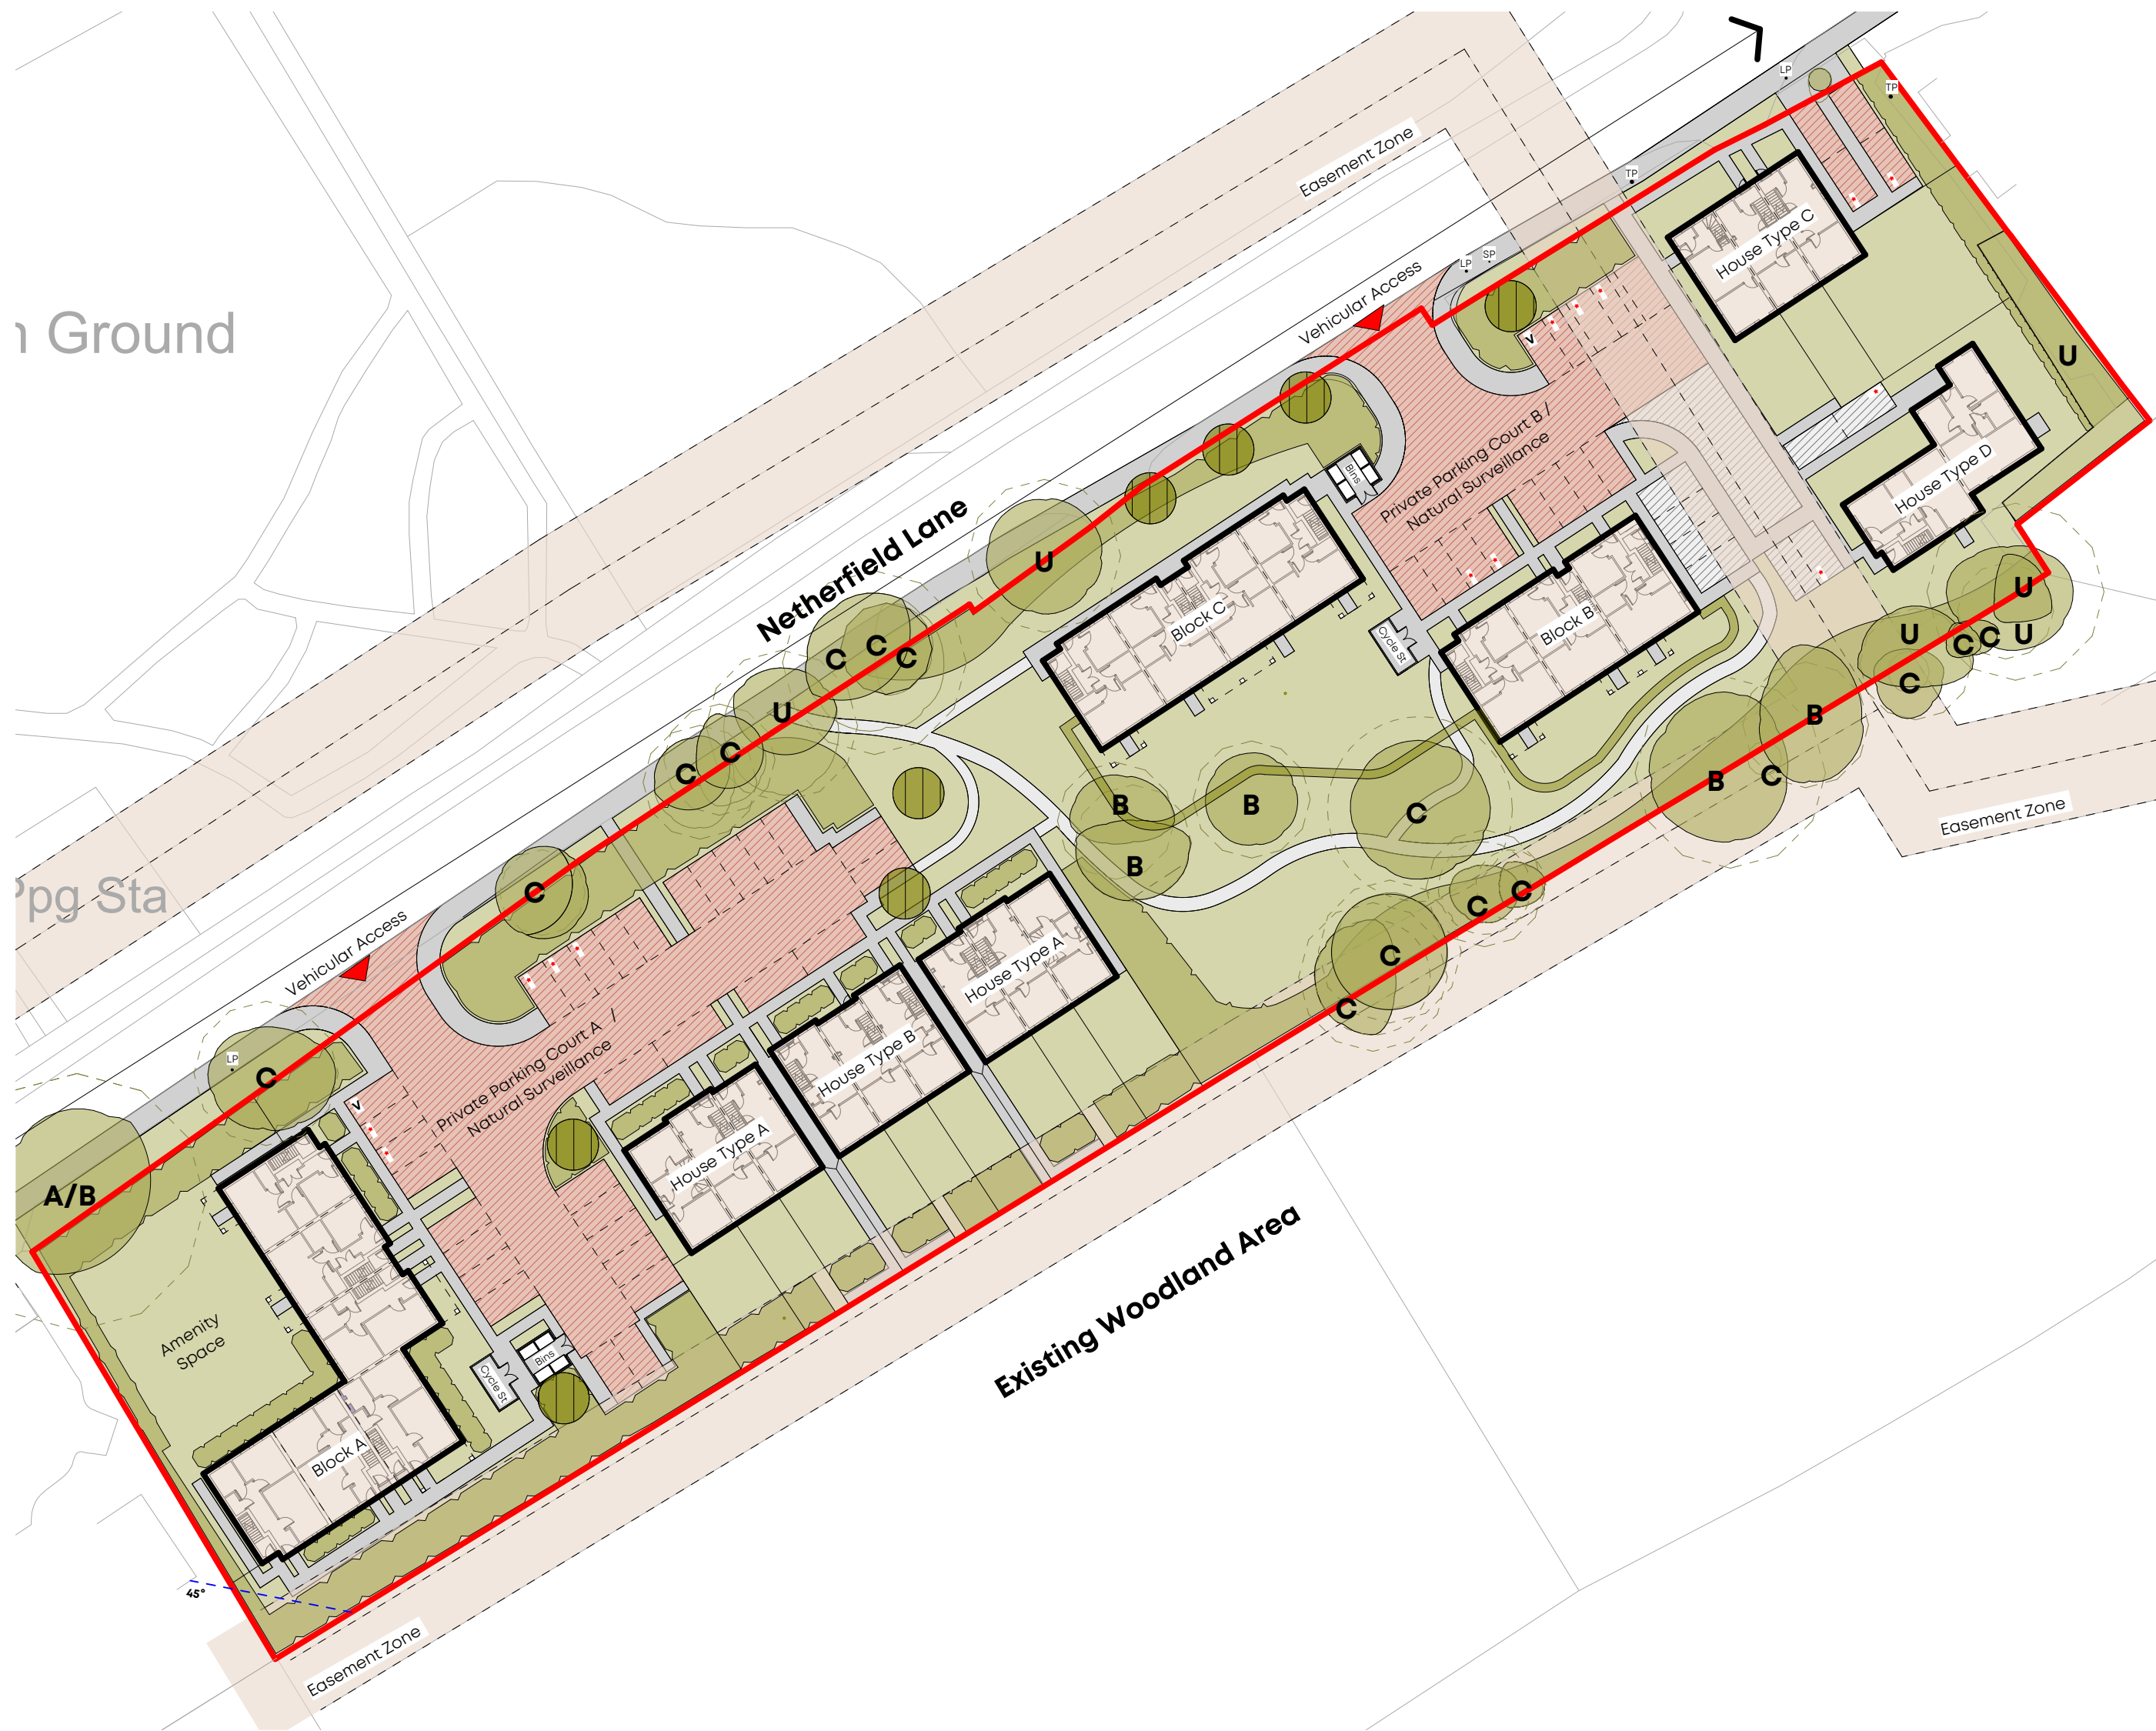
Proposed Site Layout
1:500

***** EV Charing Points
4 no. to allocated points
10 no. (20%) unallocated points
